Classifying Faults Locations in Cable Terminations and Investigation of the Faults Reasons

Abstract: Cable termination faults are problematic in electrical networks almost always. Technology has solved problems somewhat, but there are many annual reports about damaged cable terminations. For analyzing the problems, faults in two regional electricity companies are studied. At first step, damaged cable terminations are analyzed statistically and grouped according to their problems. Then, some of the damaged cable terminations are checked to classify vulnerable areas. The investigation is completed by simulation, analysis and study of equivalent circuit. Conclusions underline important points which can be helpful for reducing the damages.

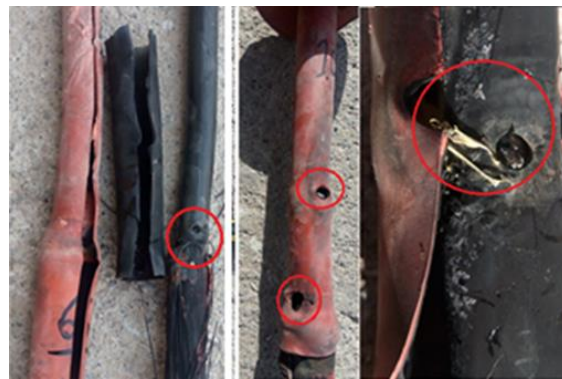
In this part fifty damaged terminations were chosen and analyzed to identify faults common regions. In most of the damaged terminations, faults occurred in connection edges of different layers. The first rank of damaged region was main triple point connection in which stress control layer (SG), XLPE and semiconductor (the most sensitive edge) connect to each other. Breakdown in main triple point punctures layers

as SG and causes flowing current between the point and ground which burns termination in the region (see Fig. 1).

About 35 terminations had damages in main triple points region (70% of faults) that introduces the region as the most sensitive part. It is anticipated 30% of the remind breakdown belong to other connection edges between layers. The connection edges between layers in cable termination are:

Fig. 1 Damaged and burned cable terminations in main triple point region.

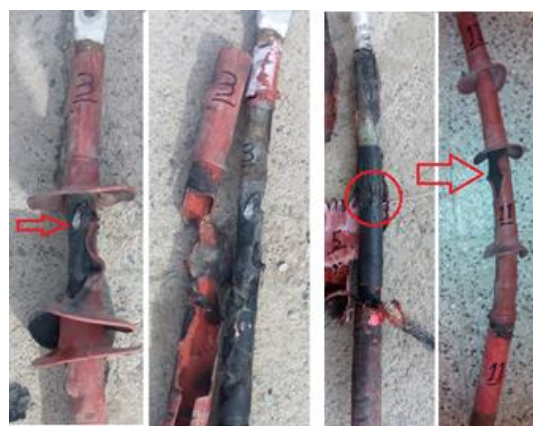
1. **Case 1-** Triple point between: XLPE, SG and silicone rubber (near cable junction);
2. **Case 2-** Connection between: silicone rubber and XLPE near cable junction;
3. **Case 3-** Triple points between: SG, XLPE and semiconductor (near the sensitive triple point).

In all of the edges, electrical field increases strongly. High value of electric field produces a high drop voltage between the edges and ground which causes partial discharge and breakdown. A short distance between the critical triple point (explained in Fig. 1) and ground impacts possibility of problems in the region. Similar problems occur in the other edges connections with less intense. However, about 30 percent of the failures assigned to the edges near case 1 and case 2 (Figs. 2 and 3).

Fig. 2 Damaged cable terminations in case 1.

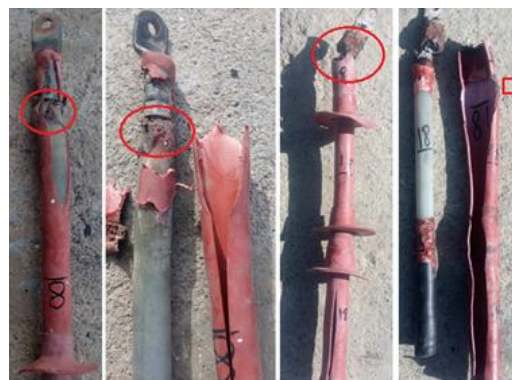
Fig. 3 Damaged cable terminations in case 2.

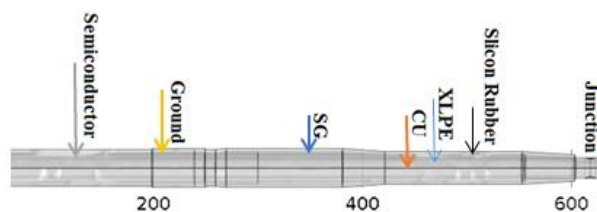
Electric field in cable terminations for assembly errors should be calculated and analyzed. Electric field simulation in cable terminations is possible by FEM method. Geometry of termination and material properties have to be imported in a software which analysis electromagnetic equations based on FEM method. According to information about system and cable termination situation, boundary conditions were defined in the software. In Fig. 4 and Table 1 geometry of simulated cable termination and layers properties are illustrated (simulations are 3D). To study assembly errors some of the geometry and boundary conditions were changed based on the case studies.

Fig. 4 Geometry of 20kV heat shrinks cable termination (diameter are in mm).

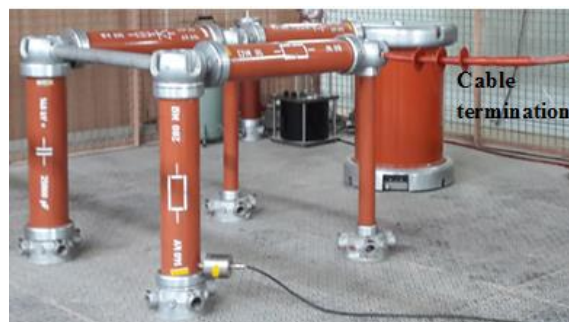
Fig. 6 HV test arrangement.

termination. Based on cable termination standard tests (IEEE Standard 48TM-2009), additional AC, DC and impulse were done. The HV tests need usual test setup as shown in Fig. 6.

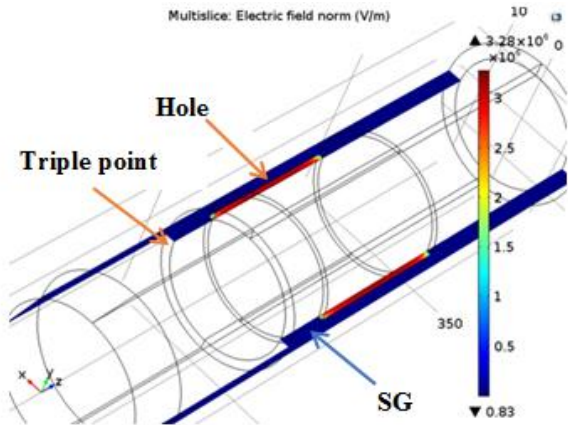
Maximum electric field in the triple point is about 2×10^5 V/m in common condition. When a void adds to the region by not enough heating in the area, electric field increases 10 times (Fig. 7). The electric field value in air void is more than air breakdown that creates PD. PD occurs continuously in each cycle and develops the void till punctures termination. In Fig. 7 void is simulated by a layer of air in which electric field would be similar to void.

Fig. 7 Electric field in a layer of air between XLPE and SG near main triple point.

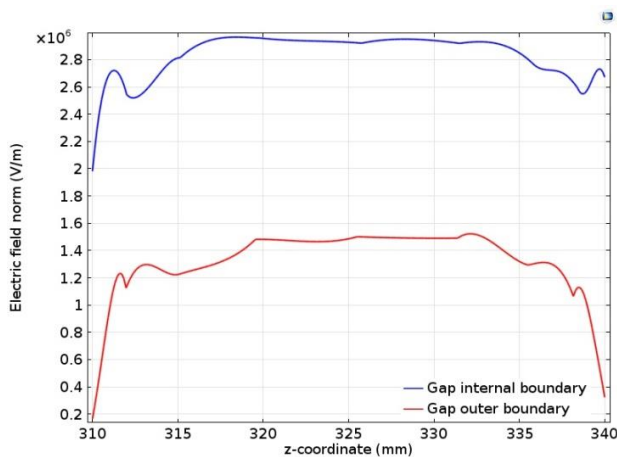
As mentioned before, electric field increases in the void or the layer of air and makes a high potential difference between both sides of the void. Insulation endurance weakness in the layer of air causes PD and breakdown. For more clarification, electric field and electric potential curves on boundary conditions are shown in Figs. 8 and 9.

Fig. 8 Electric field on internal boundary condition of the layer of air (subscribe to XLPE) and external boundary condition (subscribe to SG).

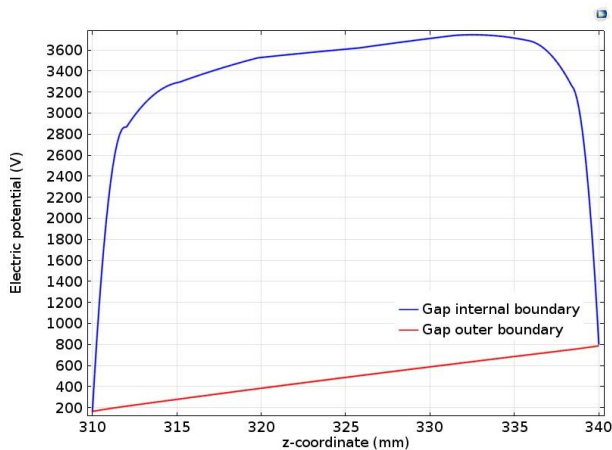
At end edges, internal and external boundaries connect to each other ($Z = 310$ mm and $Z = 340$ mm) in which there is no electric potential difference (Fig. 9). There is a constant electric potential difference between other parts of the boundaries (about 3kV/mm) and PD will occur (Fig. 9). Study of the air layer effect was done by changing its location and average electric field value (by equation (1)) in the air layer was calculated. Simulations consisted of ten cases for the layer location. Average electric field in three of them had maximum

Fig. 9 Electric potential on internal boundary condition of the layer of air (subscribe to XLPE) and external boundary condition (subscribe to SG).

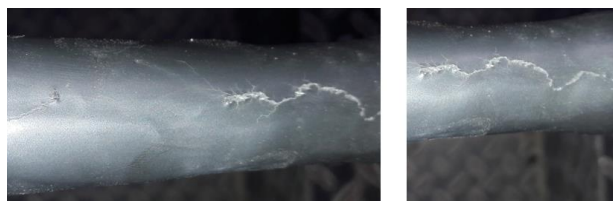
By a simple high-voltage test, impacts of remaining void are searchable (a void under SG layer and near the main triple point should be created). AC overvoltage made problems for the case study and treeing effect occurred in SG tube as shown in Fig. 10.

Fig. 10 Treeing effect in the area with void under SG.

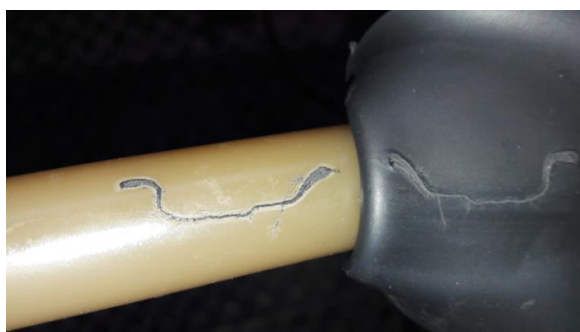
Impacts of remaining wet and pollution were studied by moistening surface under SG layer. By connecting cable termination to HV test circuit, current density increased intensively in rated voltage that damaged XLPE and SG tube as shown in Fig. 11.

Fig. 11 Fault under SG because of wet and pollution.

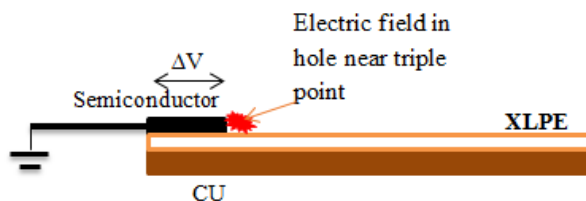
At the end of this part, the events are explained by equivalent circuit. Regions with high electric field can be assumed as an electrode and the grounded shield wire is second electrode (Fig. 12). When electric field increases in the voids area, it produces an electric potential between the electrodes. Areas as the voids with weakness in insulation endurance can't stand under stress and PD occurs in them. PDs extent the void and

Fig. 12 Drop voltage and created electrodes between void and ground.

increase drop voltage that is the reason of treeing and puncture. Possibility of the introduced fault is high when there is nonconformity near triple point connections.

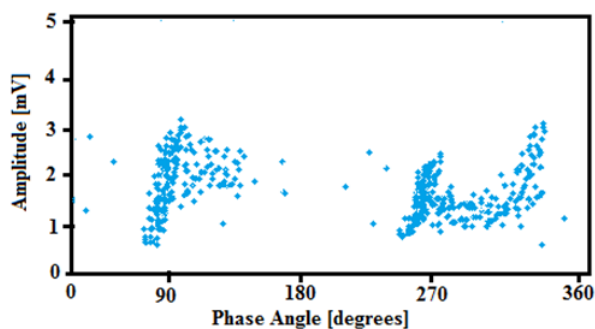
In the case with problem under SG, PD starts from 9 kV and the analyzer registers 1000 PDs point during 22-second near the triple point area (Fig. 13 contains details of the test). PD starting voltage is less than rated voltage which reduces the termination insulation lifetime quickly.

Fig. 13 Amplitude in mV during periods according to phase angles for problems under stress control tube.

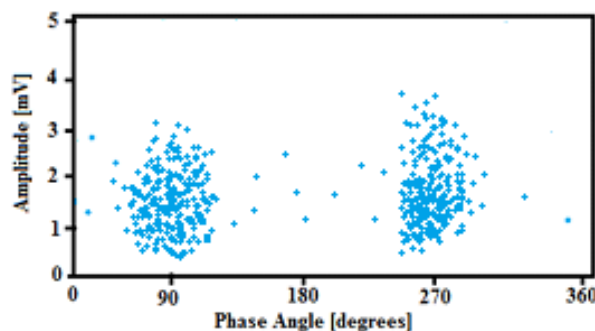
PD test helps to find cable termination with problems. In the project related to the paper topic, PD test was done for real cases in substations. PD reports for 20 cable terminations were registered and in one of them occurring PD was observed as shown in Fig. 14. In the real case, 1000 PDs occurred during several minutes which means the cable termination needs to be replaced. Most of the PDs happened in maximum voltage (Fig. 14- around 90° and 270°) and its distribution is less than PDs in Fig. 13. All the mentioned points illustrate critical situation and fault in near future (PDs cause growing its happening reasons).

Fig. 14 PD test result for cable termination in real situation- 1000 PDs registered during minutes.

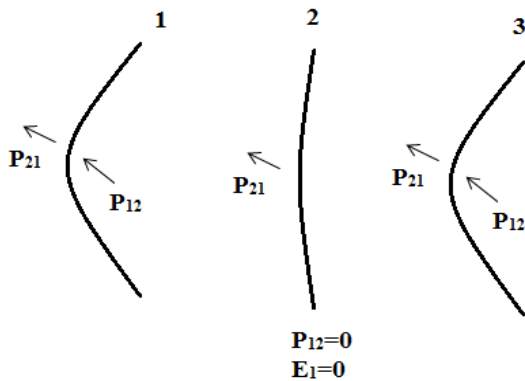
Electric field values in edges make the issue important. The condition becomes more destructive when PD occurs. During PD, electric field in one side is equal to zero which makes the pressures unbalanced. Due to the number of PDs in critical situations (as the test result), high frequency stress and shakes intensify exhaustion. Fig. 15 shows different forms of boundaries between a void and insulation layer during PD. In the steps of Fig. 15, shaking the boundary is obvious which can exhaust insulation and decrease insulation lifetime. Exhausting can cause mechanical breakdown in termination or lead to reduce mechanical durability as shown in Fig. 16.

Fig. 15 Deformations during PD in void-insulation boundary- 1) balanced pressures from 2 sides- 2) unbalanced pressures during PD- pressure from one side- 3) balanced pressures from 2 sides.

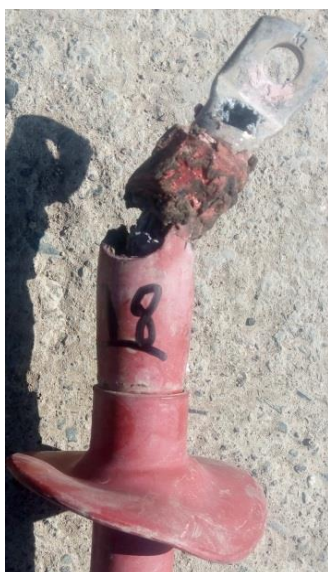
Fig. 16 Damaged cable termination because of breakdown and electro-mechanical forces.
